John, Homeowner
1234 Hometown RD,
Anytown, MI 48129
313-555-1212
Inspection Number

Inspected By:
Home Inspector

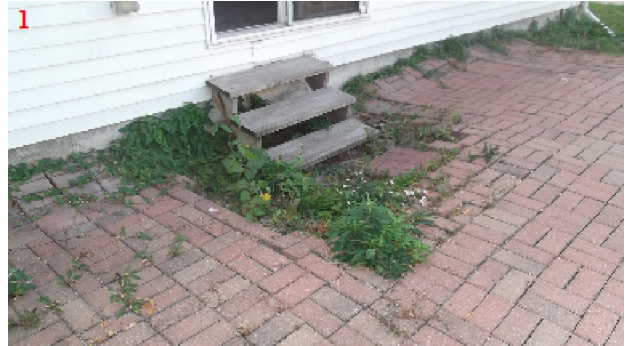
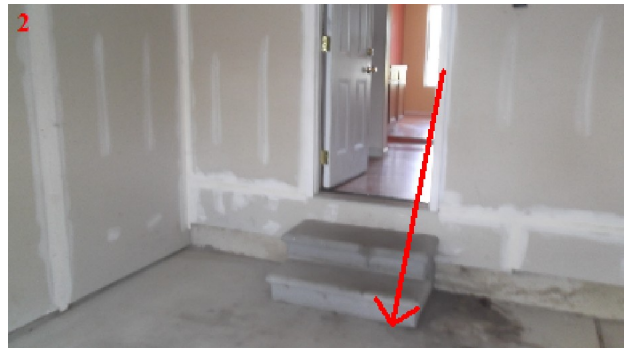
The back steps need to be replaced and should have a handrail until replacement for safety.

You should consider a handrail for the garage steps for safety also.

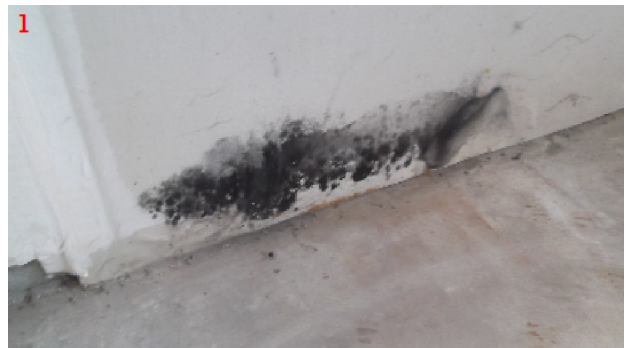
Garage Interior Walls

A discoloration was noted. It is possible that the discoloration could be mold and/or mildew. Mold, mildew and air quality testing are not part of this home inspection. You are advised to do testing to determine what this substance is, the source and/or cause of this substance, the extent of the problem and the cost of remediation and repairs.

The source and/or cause of the discoloration was not determined.

There is an open area at a corner that should be sealed closed.

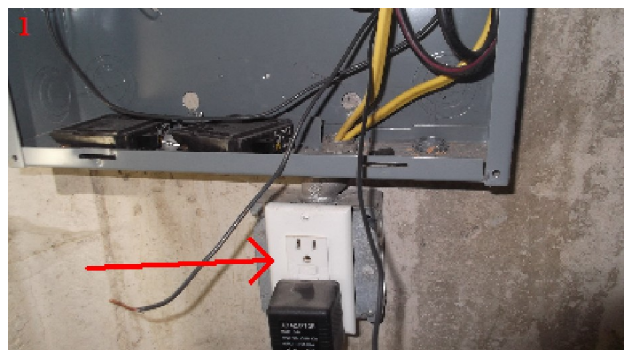
Breakers in Use

Some panel knock outs have been removed and their are no breakers installed. Seal off breaker openings if not utilized for safety.

There could be some breakers that are no longer working. There are several electrical 110 outlets in the basement and on the main floor that are not getting electricity.

There are also GFCI outlets that are not resetting. The GFCI's could be the cause of the electrical receptacles not getting electricity. Not verifiable. The GFCI's will need to be replaced.

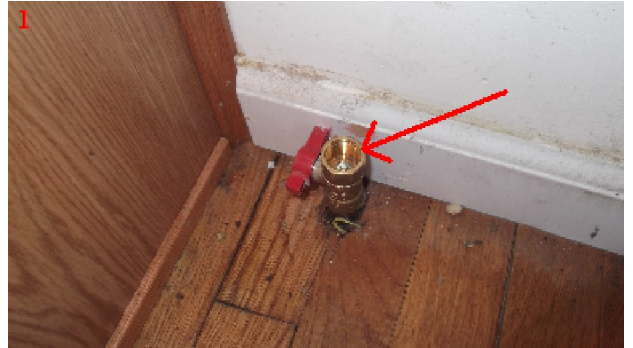
Gas Lines

Unused gas lines need to be capped for safety.

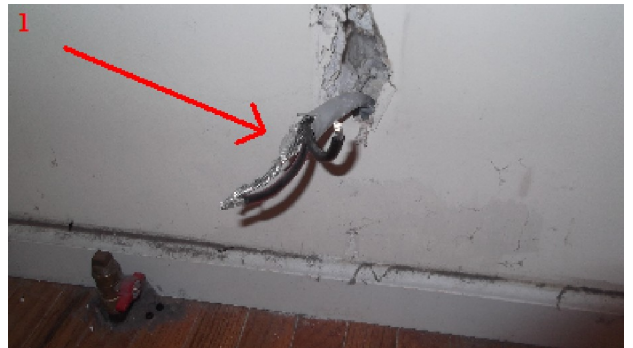
Laundry Energy Source

Exposed wiring, missing 220 receptacle.

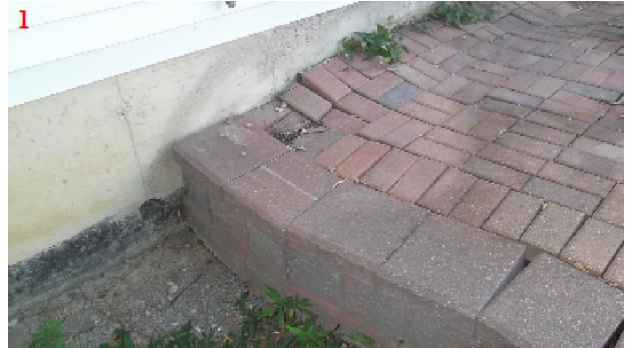
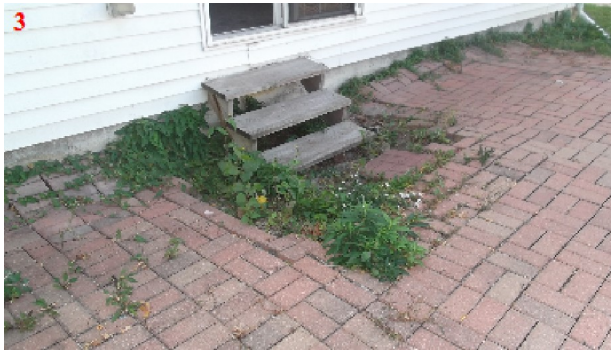
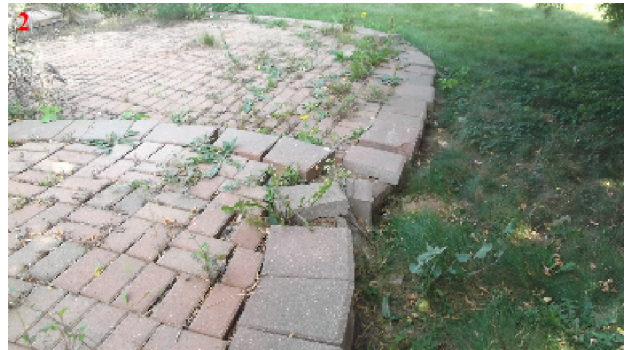
Patio

The paver system was installed incorrectly and there are several areas that are and have failed. Low areas pose trip hazards. It appears the materials can be used again if needed.

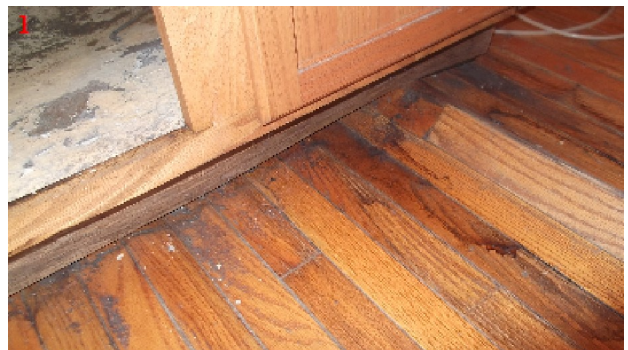
Kitchen Floors

There is extensive damaged to some of the wood flooring I suspect from some kind of water flooding. Buckling noted. Anticipate expensive cost to replace and repair.

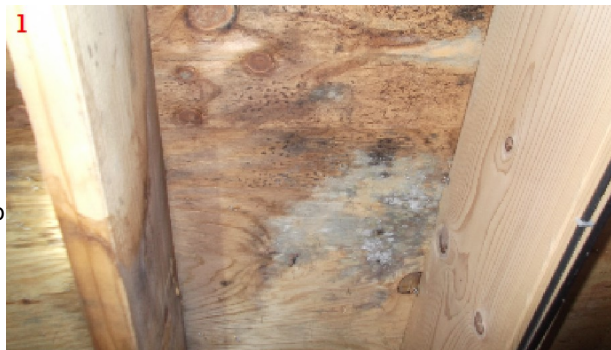
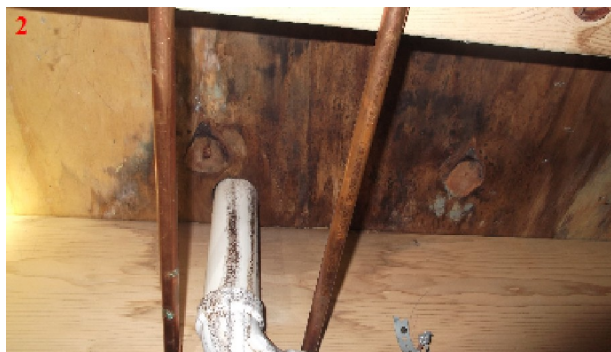
A discoloration was noted. It is possible that the discoloration could be mold and/or mildew. Mold, mildew and air quality testing are not part of this home inspection. You are advised to do testing to determine what this substance is, the source and/or cause of this substance, the extent of the problem and the cost of remediation and repairs.

There is water damage I believe is from the kitchen. You may need to replace some of the plywood sub flooring. Further evaluation is needed. Replacing sub flooring can be expensive.

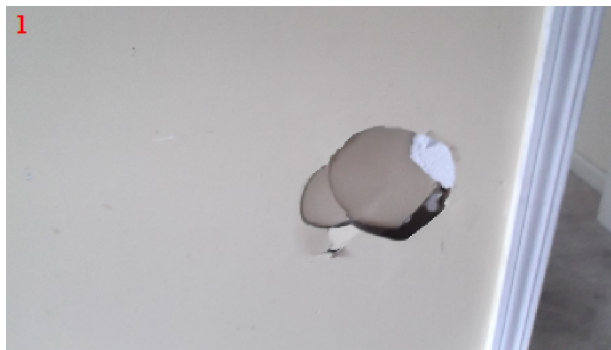
Interior Walls

There is typical drywall/plaster damage noted. They are usually not a structural issue. Repairs are considered normal maintenance.

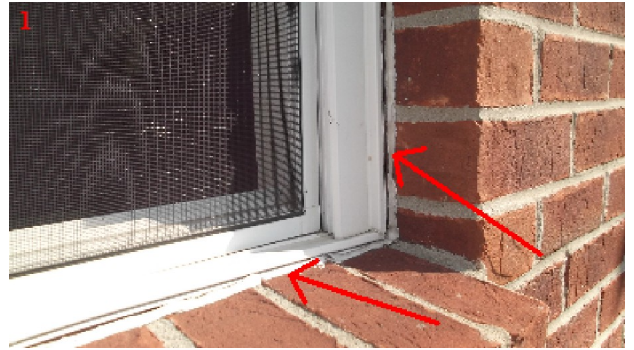
Window Character Material

Several of the windows need new exterior caulking.

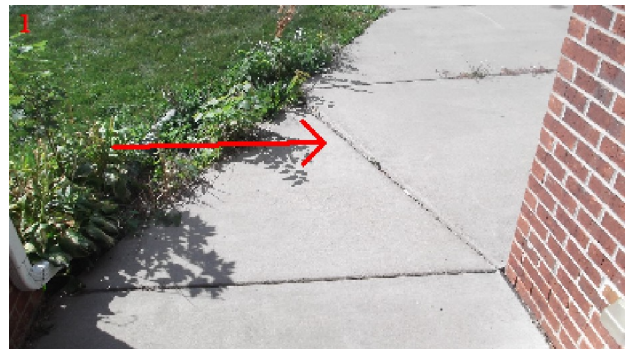
There is a area of concrete that has settled and poses at trip hazard. Repairs needed at this time.

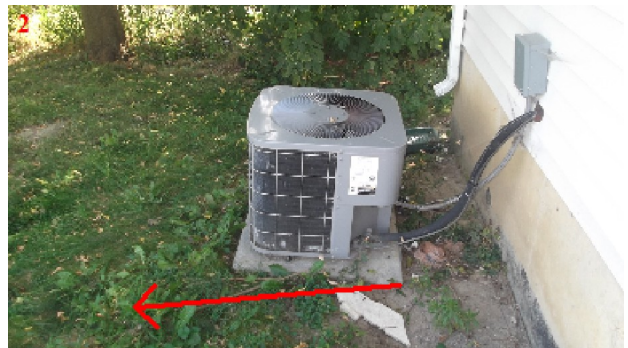
System Coils and Fins

There is fin damage visible.

The AC needs to be leveled correctly.

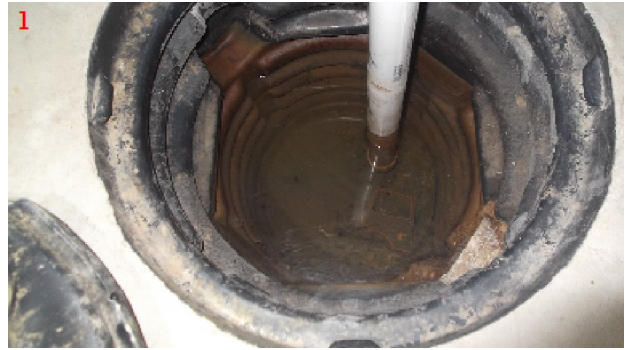
The pump has been removed. A sump pump is needed at this time and I recommend a power backup system installed.

There is water inside of the pit at the time of the inspection. I cannot predict if the pit will over flow.

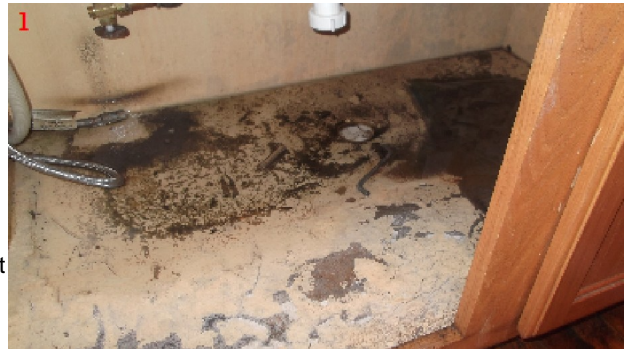
Missing and damaged cabinetry.

There is standing water inside of the cabinet under the kitchen sink. It may be likely you may have to discard some of the cabinetry.

There is some water damaged drywall and base board molding.
