**John, Homeowner**  
1234 Hometown RD,  
Anytown, MI 48129  
313-555-1212  
Inspection Number

Inspected By:  
Home Inspector

Client Information:  
John, Homeowner  
1234 Hoemtown RD.  
Anytown, MI 48129

FRONT VIEW

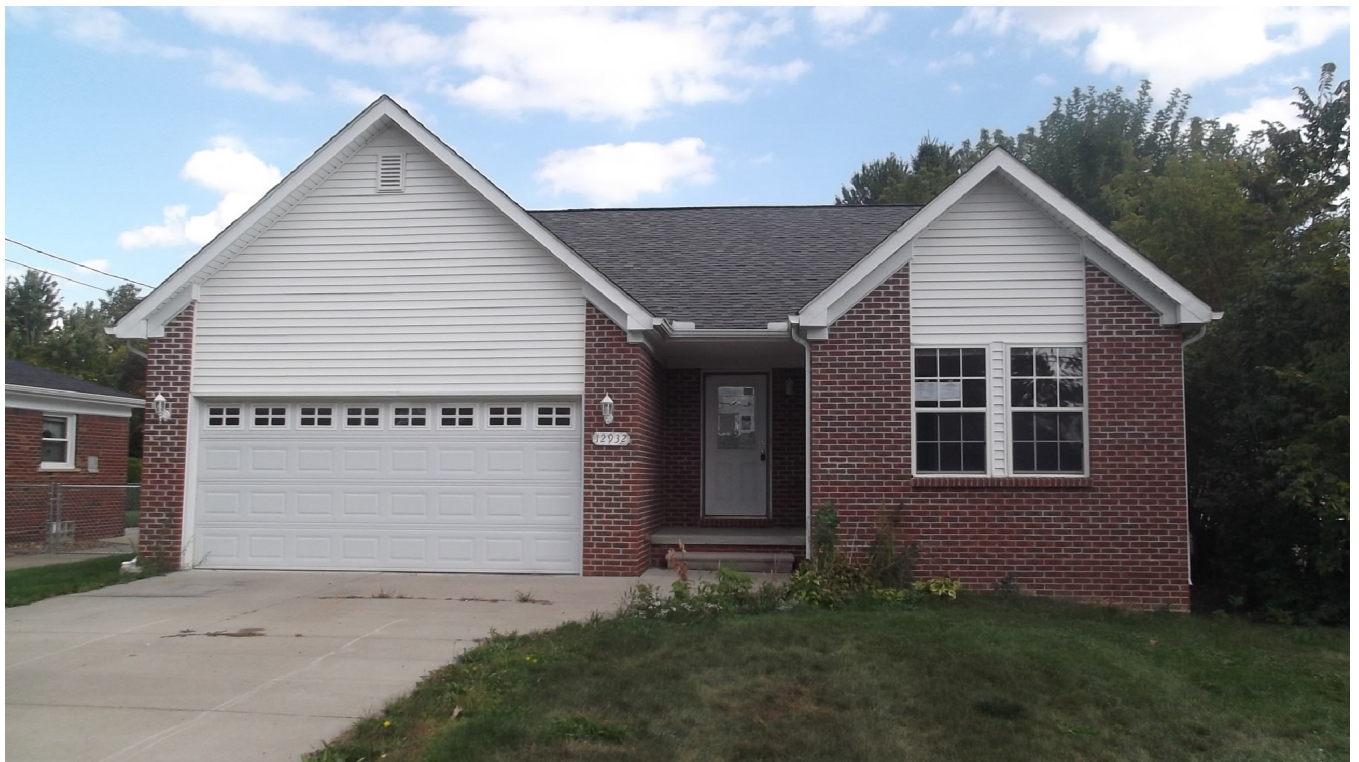
The home is facing West, the weather is warm and partly cloudy.

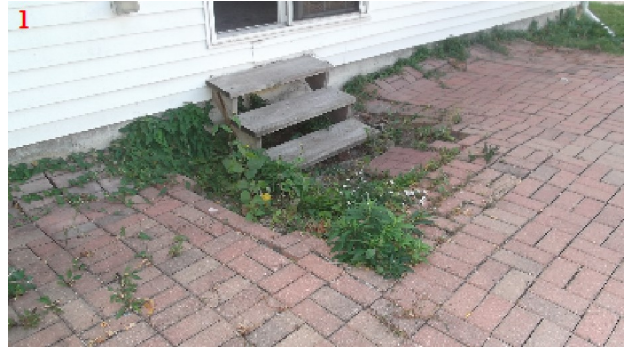
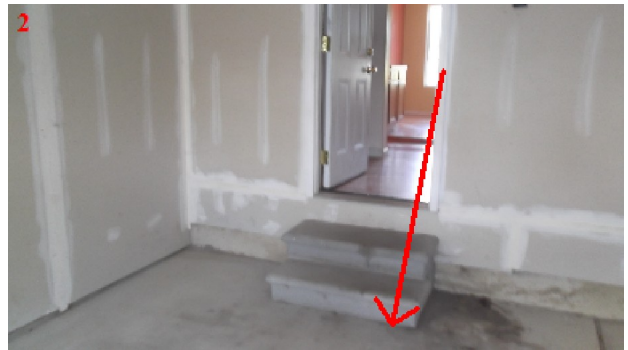
#### Steps

The back steps need to be replaced and should have a handrail until replacement for safety.

You should consider a handrail for the garage steps for safety also.

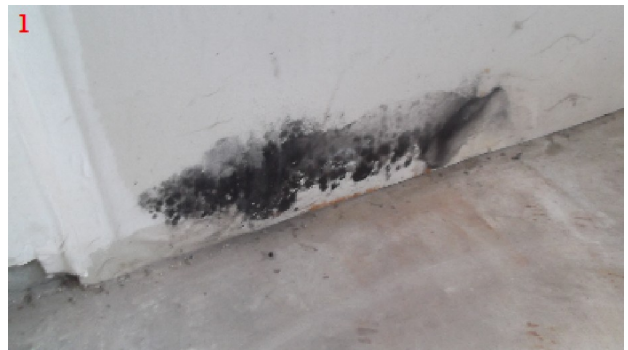
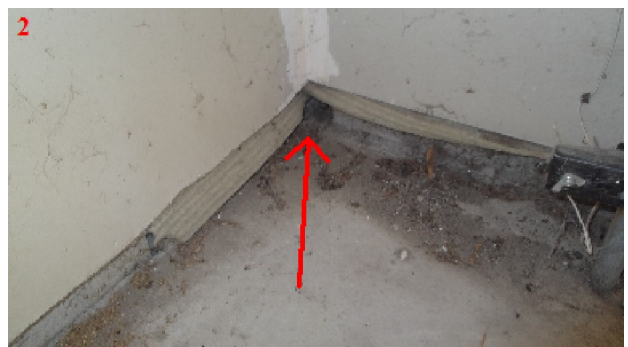
#### Garage Interior Walls

A discoloration was noted. It is possible that the discoloration could be mold and/or mildew. Mold, mildew and air quality testing are not part of this home inspection. You are advised to do testing to determine what this substance is, the source and/or cause of this substance, the extent of the problem and the cost of remediation and repairs.

The source and/or cause of the discoloration was not determined.

There is an open area at a corner that should be sealed closed.

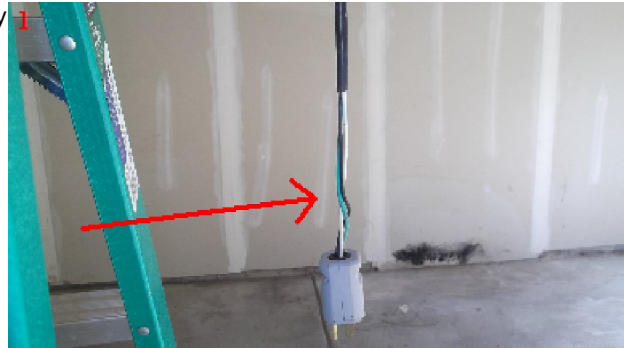
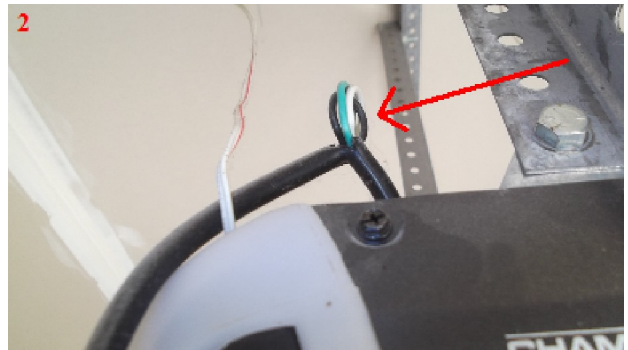
## Garage Overhead Door

The electric garage door opener was not cycled, there is no electricity available at the time of the inspection.

The plastic sheathing is missing on the power cord. Repairs needed for safety reasons.

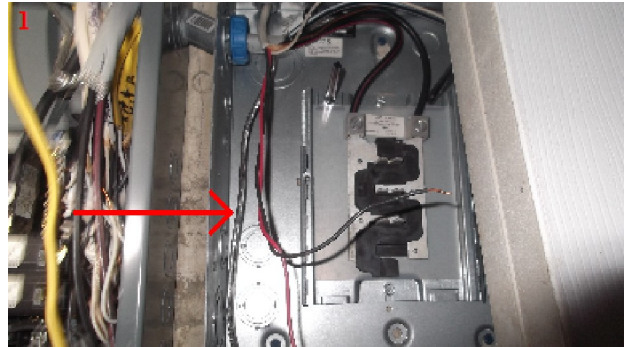
### ELECTRICAL SYSTEM

There is exposed wiring that needs to be corrected for safety.

The panel covers have been removed and need to be installed for safety.

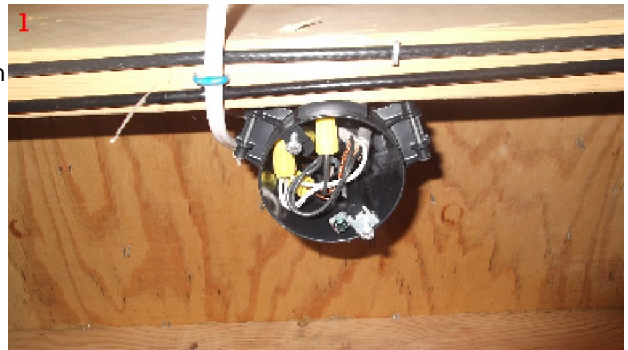
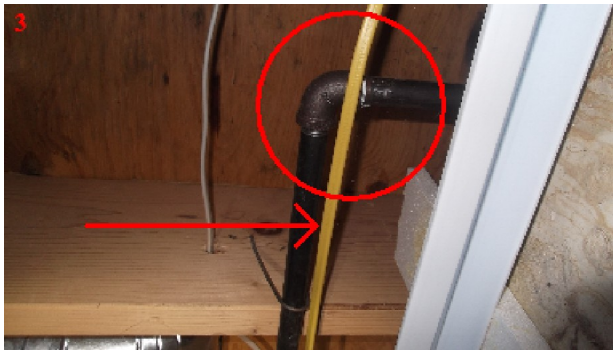
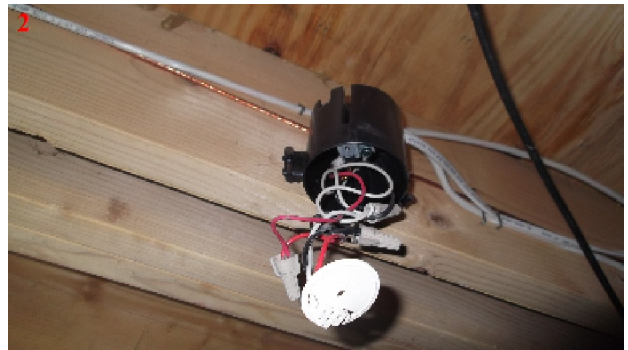
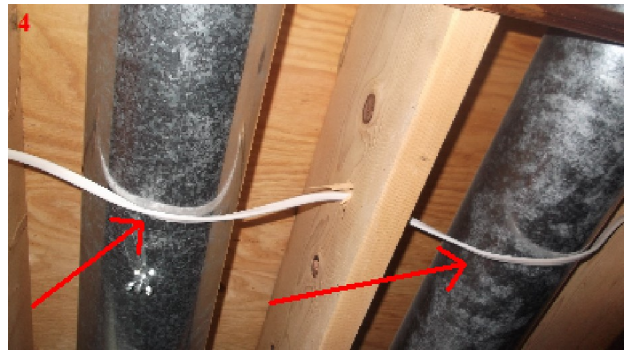
## Type of Wire

There are several open junction boxes that need to be covered.

Electrical wiring in contact with a gas line and metal ducts, separation is needed for safety.

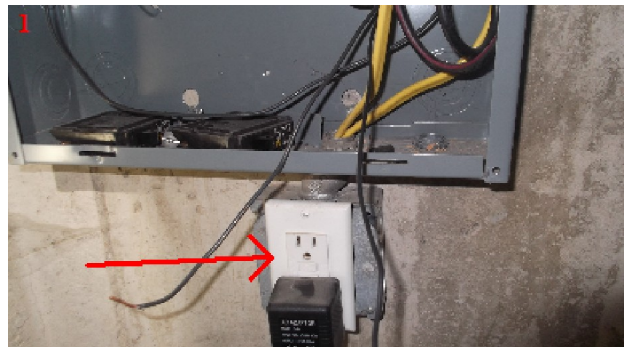
## Breakers in Use

Some panel knock outs have been removed and their are no breakers installed. Seal off breaker openings if not utilized for safety.

There could be some breakers that are no longer working. There are several electrical 110 outlets in the basement and on the main floor that are not getting electricity.

There are also GFCI outlets that are not resetting. The GFCI's could be the cause of the electrical receptacles not getting electricity. Not verifiable. The GFCI's will need to be replaced.

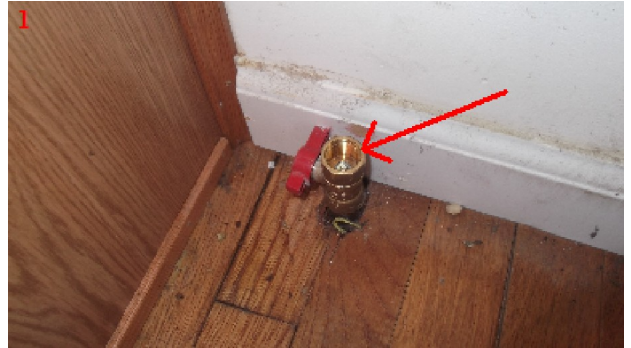
#### Gas Lines

Unused gas lines need to be capped for safety.

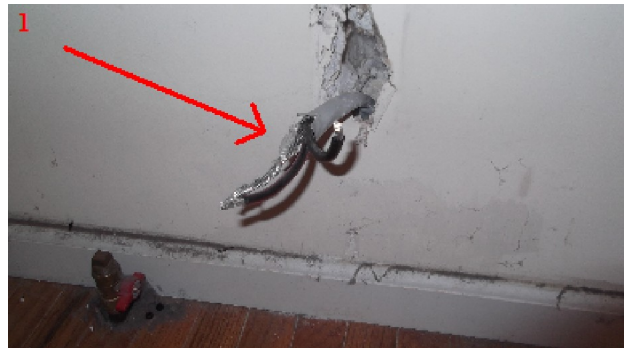
#### Laundry Energy Source

Exposed wiring, missing 220 receptacle.

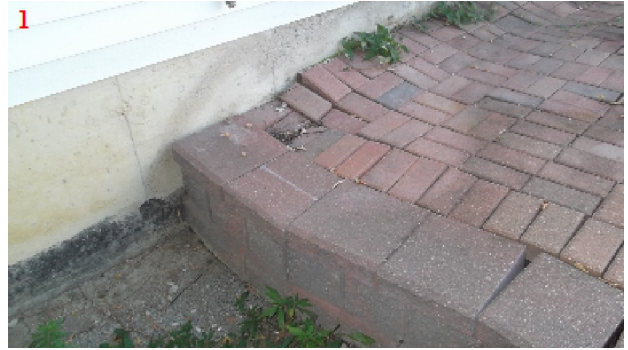
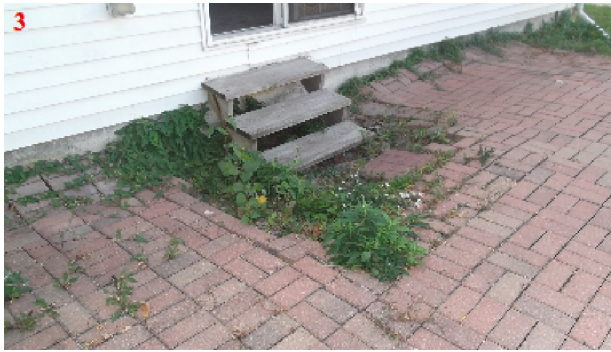
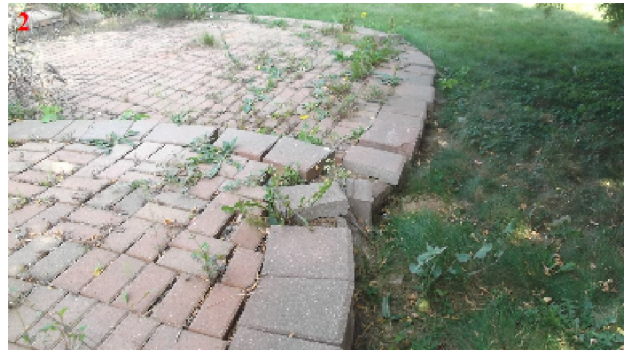
### Patio

The paver system was installed incorrectly and there are several areas that are and have failed. Low areas pose trip hazards. It appears the materials can be used again if needed.

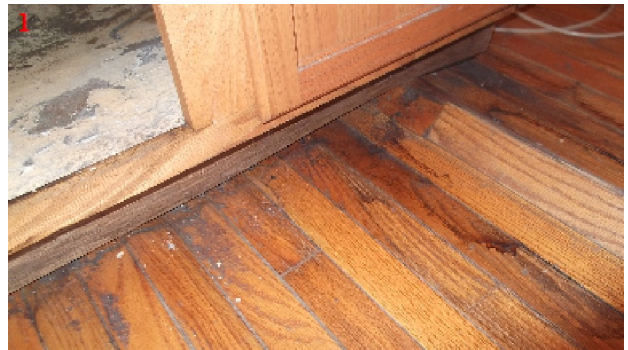
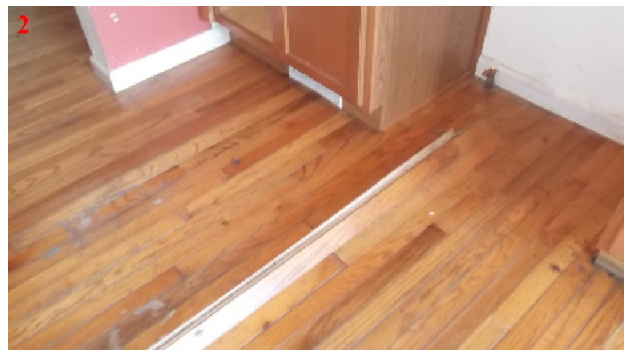
### Kitchen Floors

There is extensive damaged to some of the wood flooring I suspect from some kind of water flooding. Buckling noted. Anticipate expensive cost to replace and repair.

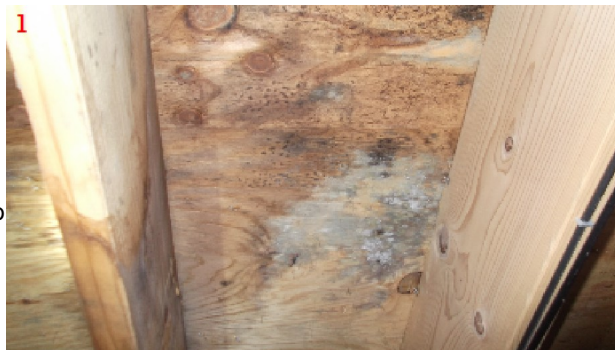
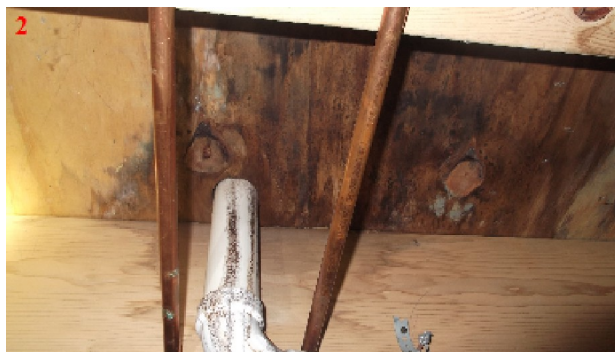
### Basement Ceiling Sub Floor

A discoloration was noted. It is possible that the discoloration could be mold and/or mildew. Mold, mildew and air quality testing are not part of this home inspection. You are advised to do testing to determine what this substance is, the source and/or cause of this substance, the extent of the problem and the cost of remediation and repairs.

There is water damage I believe is from the kitchen. You may need to replace some of the plywood sub flooring. Further evaluation is needed. Replacing sub flooring can be expensive.

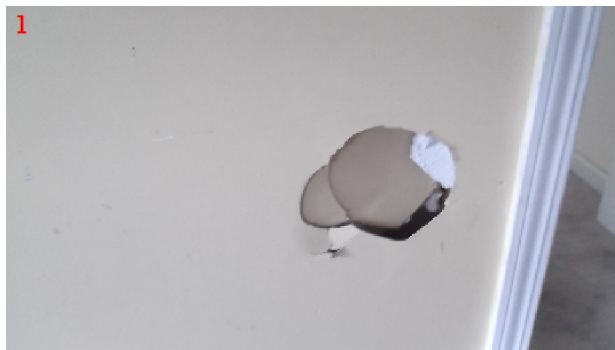
### Interior Walls

There is typical drywall/plaster damage noted. They are usually not a structural issue. Repairs are considered normal maintenance.

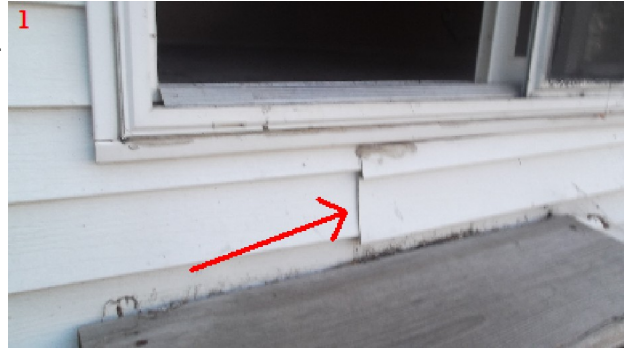
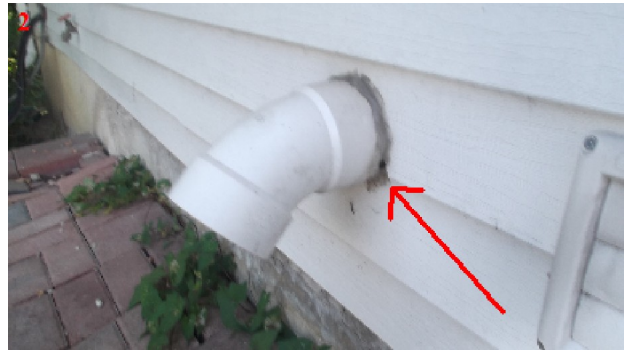
### Siding

There is loose pieces at the back that need to be repaired then sealed correctly.

Better caulking is needed at PVC pipes at the exterior.

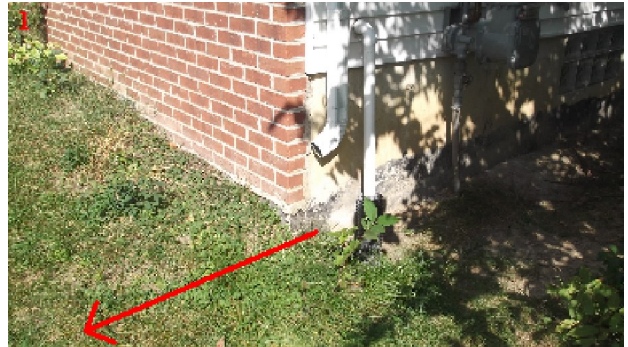
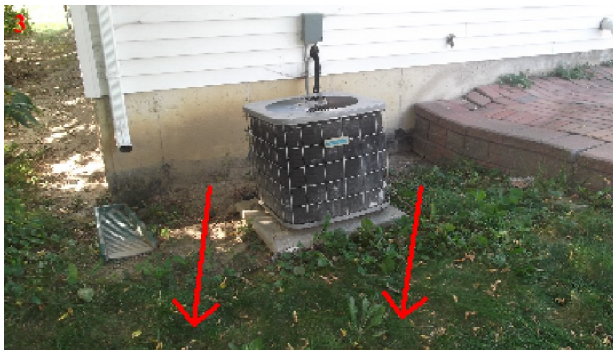
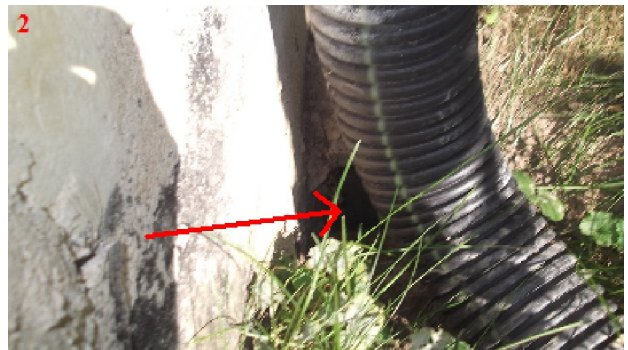
### Grading

There is poor grading around the foundation walls. The water is not discharging away from the foundation walls correctly.

There appears to be a varmint hole behind a gutter down spout. not verifiable.

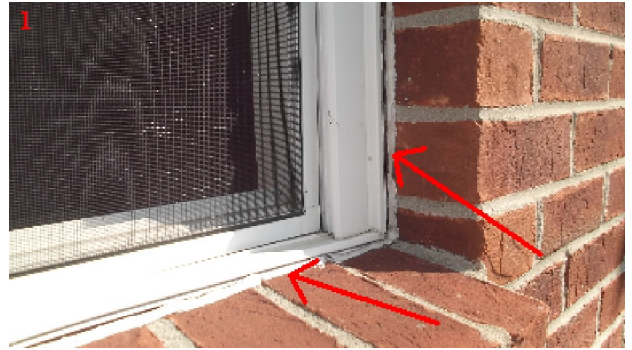
### Window Character Material

Several of the windows need new exterior caulking.

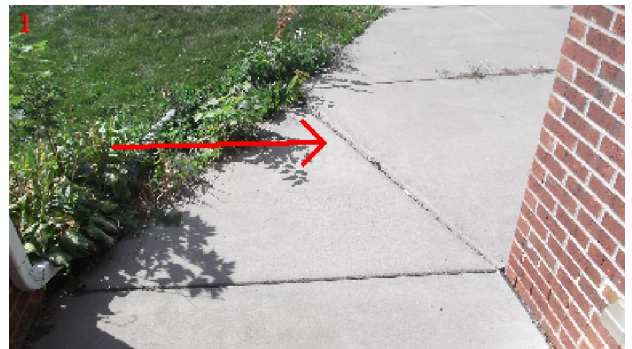
### Walks

There is a area of concrete that has settled and poses at trip hazard. Repairs needed at this time.

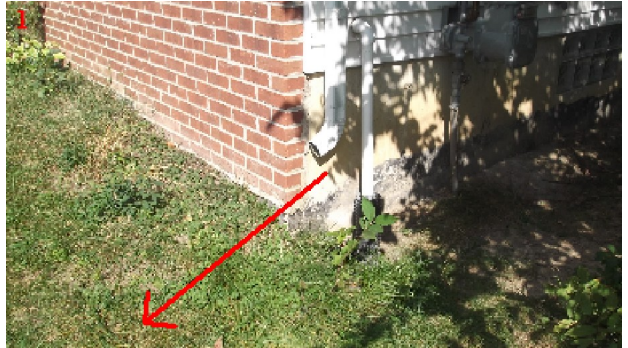
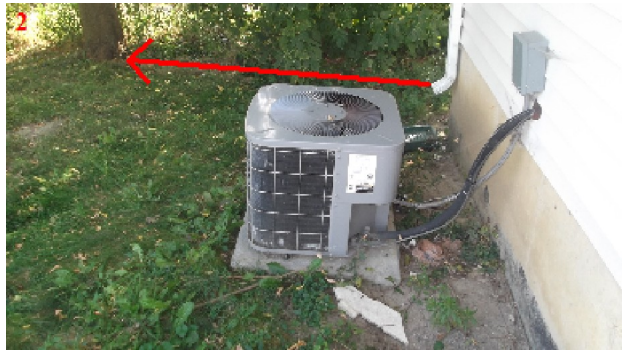
### Downspout Extensions

There is one down spout that needs a longer extension to make sure water is discharging correctly away from the AC unit. Safety concern visible.

Extensions should be added to the gutter down spouts to discharge the water farther away from the home and it's components. I suggest 6 to 8 feet in length.

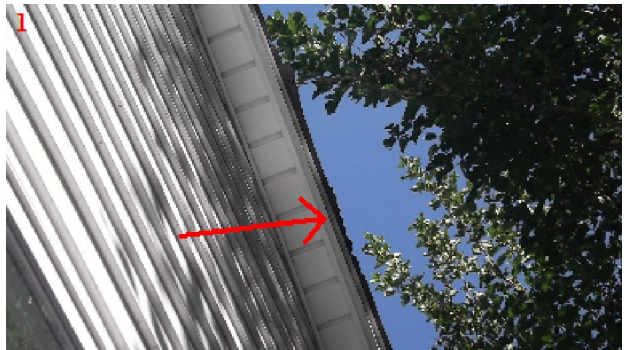
### Roof Covering

There are some damaged shingles noted at the roofs edge. Monitor.

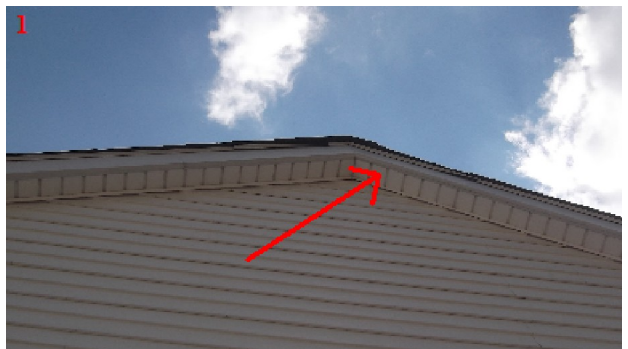
### Drip Edge

There are open and/or damaged areas that can allow water penetration. Repairs and correct sealing is needed. Any damage that is not visible behind the drip edge was not visible and not verifiable. Future water penetration and/or damage cannot be predicted.

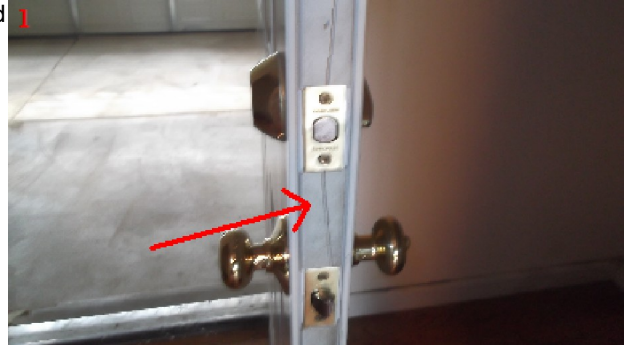
#### Garage Entry Door

There is damage noted, crack. The door does close correctly.

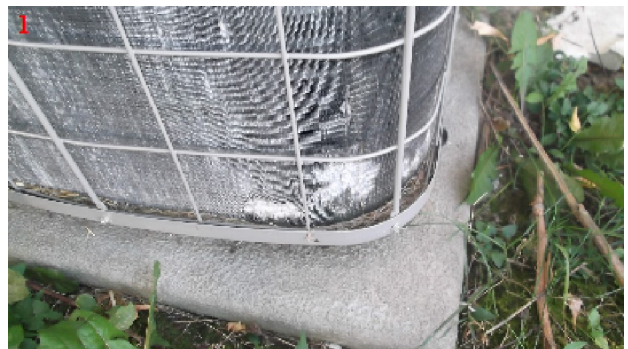
#### System Coils and Fins

There is fin damage visible.

The AC needs to be leveled correctly.

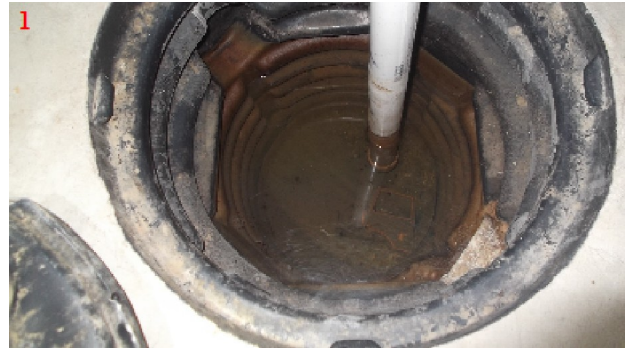
### Sump Pump

The pump has been removed. A sump pump is needed at this time and I recommend a power backup system installed.

There is water inside of the pit at the time of the inspection. I cannot predict if the pit will over flow.

I could not inspect any of the pump discharge line and it's components due to there is no pump installed.

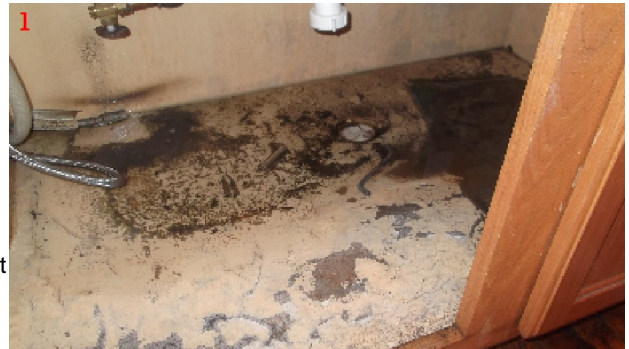
### Kitchen Cabinets

A discoloration was noted. It is possible that the discoloration could be mold and/or mildew. Mold, mildew and air quality testing are not part of this home inspection. You are advised to do testing to determine what this substance is, the source and/or cause of this substance, the extent of the problem and the cost of remediation and repairs. Safety concern.

Missing and damaged cabinetry.

There is standing water inside of the cabinet under the kitchen sink. It may be likely you may have to discard some of the cabinetry.

There is some water damaged drywall and base board molding.

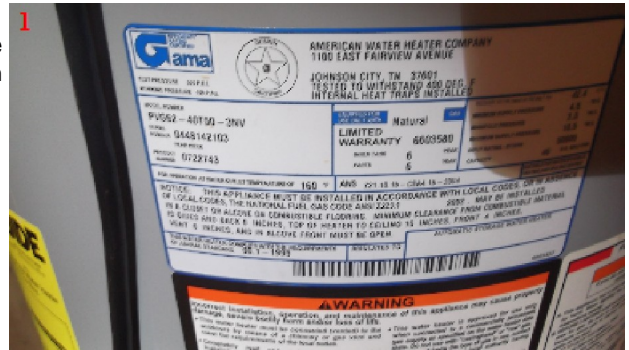
### Water Heater 1 Approx. Age

12 years of age is what could be expected for the life longevity of a water heater. As this appliance gets older, you should monitor. There is no guarantee of the life longevity of the water heater. Adding a pan with a drain plug and drain line that discharges water into a drain incase of failure could help from extensive water damage. Manufacture build date is approximately 2005.

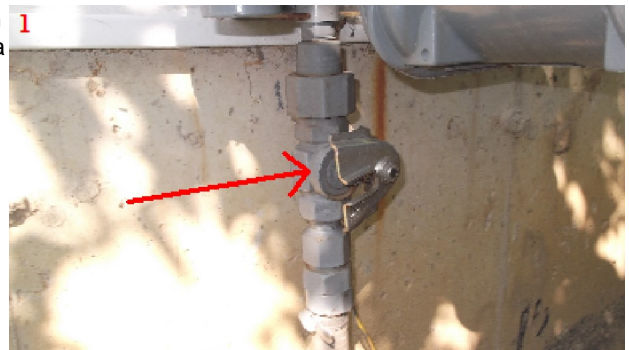
### FURNACE

The system and it's components were not cycled and/or inspected. The gas to the appliance is turned off. The gas is off to the home.

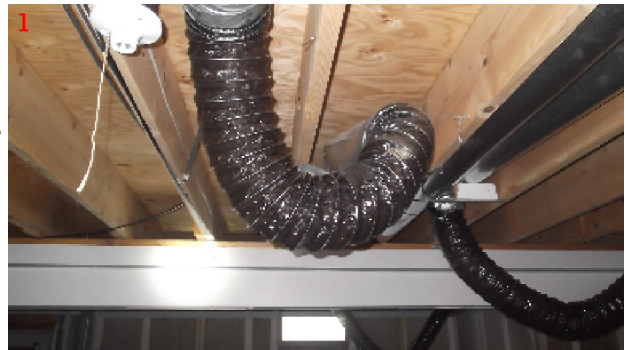
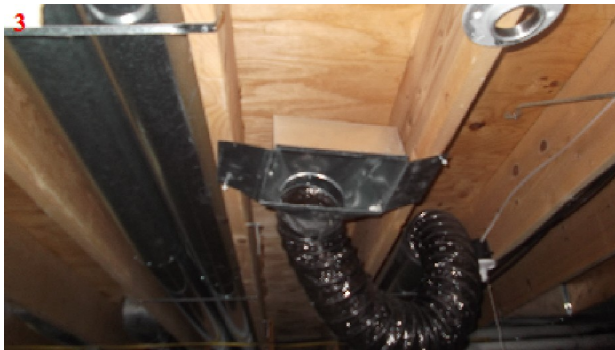
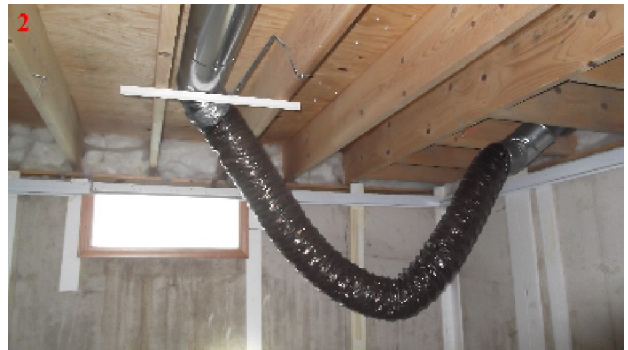
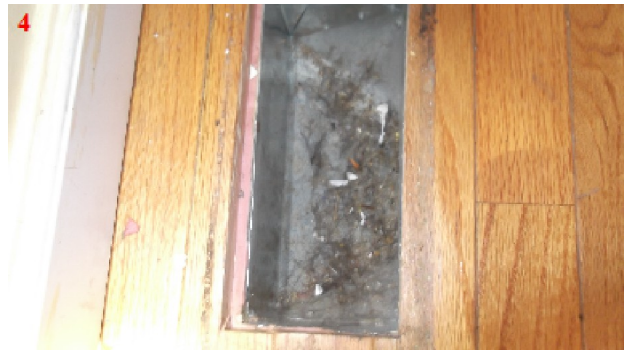
## Duct Work

Loose areas of duct that need to be anchored correctly.

Unfinished components.

You may want to clean the ducts and trunks. Dirty and there is debris inside of the floor registers.

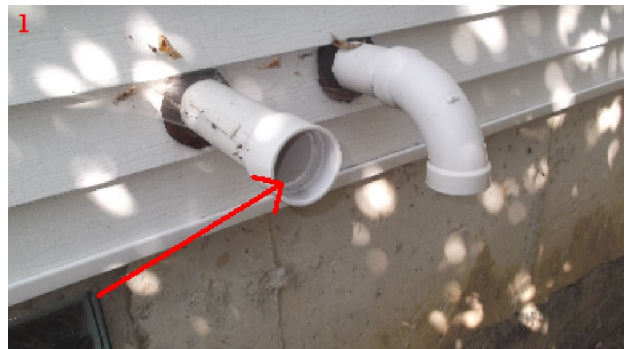
## Flue Piping

A screen should be added to the exterior pipe.

Better caulking is needed at the exterior wall where the lines are.

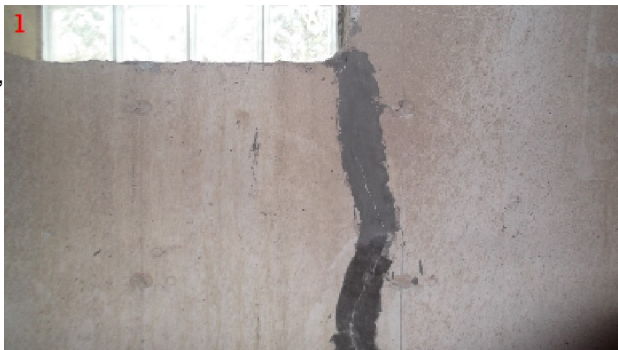
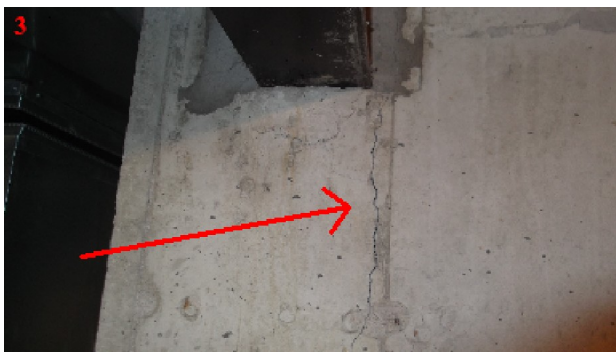
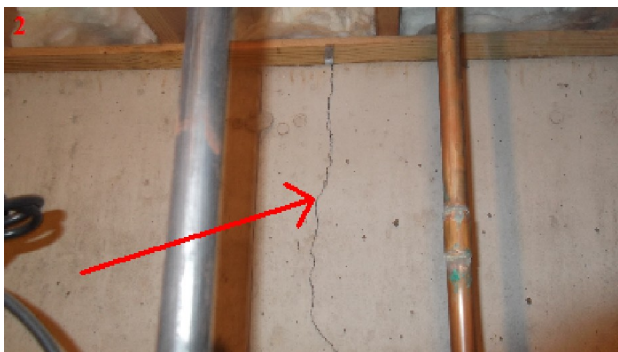
### Basement Foundation Walls

Improper repaired settling crack. Injection the crack with a epoxy should seal the crack correctly.

There are typical settling cracks noted with no signs of water penetration at the time of this inspection.

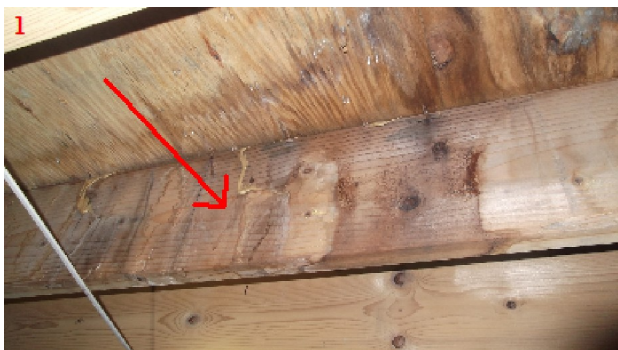
### Basement Ceiling Joist

A discoloration was noted. It is possible that the discoloration could be mold and/or mildew. Mold, mildew and air quality testing are not part of this home inspection. You are advised to do testing to determine what this substance is, the source and/or cause of this substance, the extent of the problem and the cost of remediation and repairs.

Water damage I believe is from the kitchen. You may not need to change out the wood joist. Further evaluation needed.

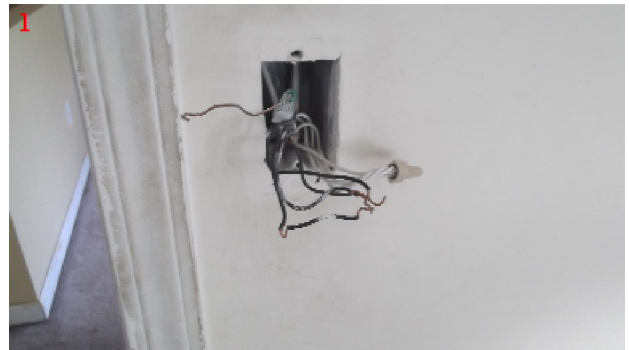
## Interior Switches

The front door bell does not work.

Some were not working at the time of the inspection. There are missing switches and plate covers. Exposed wiring poses safety concerns.

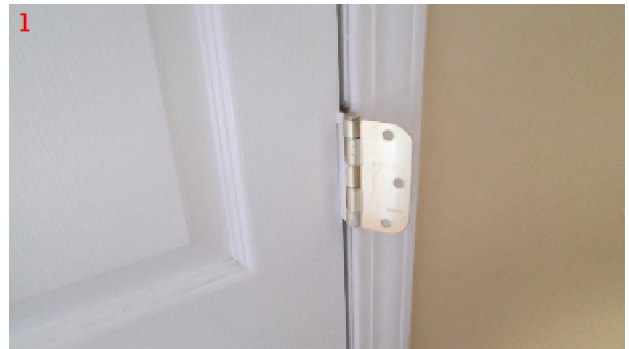
## Closets

There are doors that are missing at the time of the inspection.

Improperly installed door hinges.

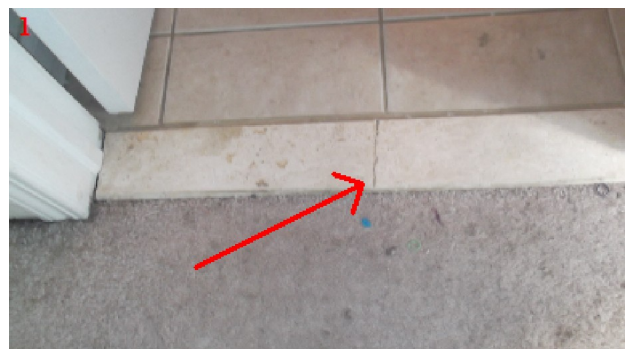
### Doors and Windows

Cracked marble door thresh hold.

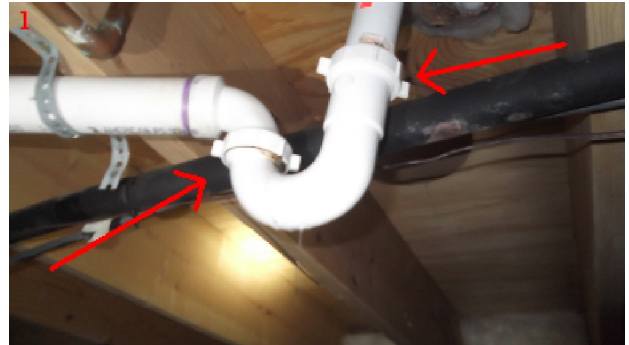
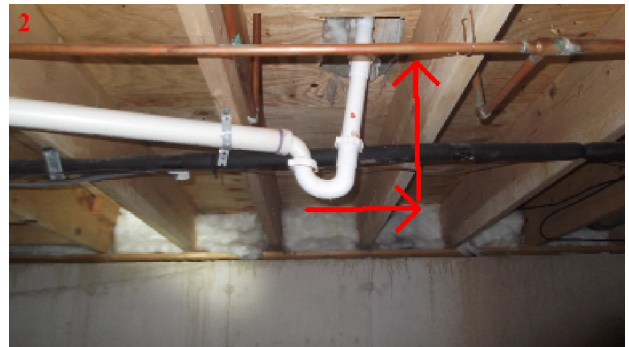
### Bathub Stopper

There is active leaking noted at the waste line and trap areas. There appears to be loose compression fitting. The trap is not vertically installed correctly. repairs needed at this time.
